TECHNICAL CIRCULAR

DOC No.: HHI-TEC-0441

**SUBJECT: UNIC CONTROL SYSTEM REGULAR REBOOTING
INTERVAL**

**TYPE: ALL WINGD ENGINE WITH UNIC ENGINE CONTROL
SYSTEM**

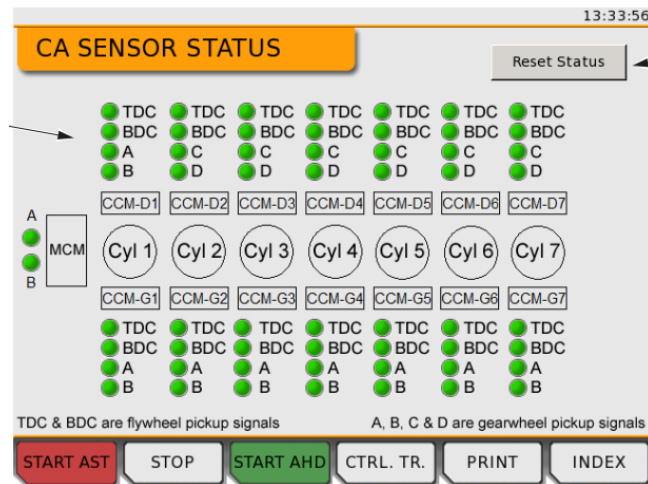
Figure 3-1: LDU (Local Display Unit) Crank Angle (CA) status

Prior to restarting the engine after rebooting the UNIC ECS, it is mandatory to perform at least one full revolution of the engine by using the turning gear. This is to restore the correct Crank Angle (CA). In the respective LDU page the status of the CA system be as shown in Figure 3-1.

For emergency cases after a crank angle loss, when the engine must become operational immediately, an engine start command will initiate the automatic Angle Determination Algorithm (ADA) function. However, this must be used only in an emergency case since there is a potential risk of damaging the scavenge air flaps if the crankshaft stands in an unfortunate position.
