TECHNICAL CIRCULAR

DOC No.: HHI-TEC-0457

**SUBJECT: STANDARD TOOL OF EXHAUST VALVE GRINDING
MACHINE FOR EXHAUST VALVE SPINDLE AND SEAT
ON NEW MAN-ES ENGINES**

TYPE: ALL HYUNDAI-MAN B&W 2-STROKE ENGINES

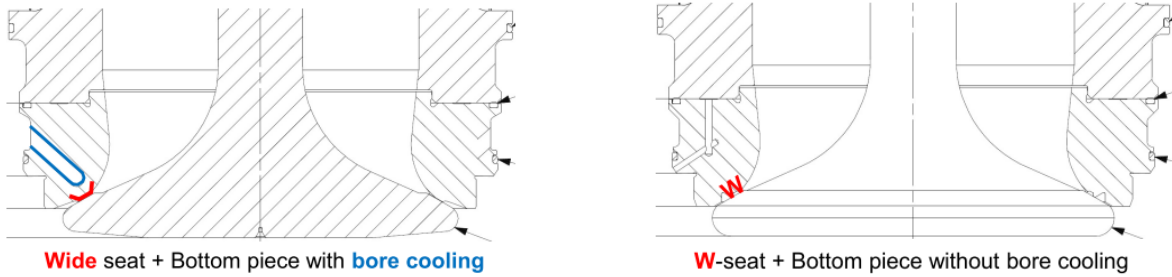
Figure: Exhaust valve bottom piece design

The one of reason was that the W-seat design of exhaust valve bottom piece has an ability to minimize the dent mark size compared to the wide-seat design, and the W-seat also excellent on the ability to crush seat deposits meaning that the W-seat are more forgiving if the seat contact are not kept clean. Furthermore the W-seat has an ability to make firm seat contact on both seats in the contact, even if the seat angle difference between spindle and bottom piece are slightly out of Spec.

However, the W-seat has one major drawback, being that the spindle cooling are diminished due to the minor thermal seat contact, compared to wide-seat.

According to the trend of engine development, the combustion process has developed in a direction that put more and more heat load on the exhaust valve spindle. This development has been forced to re-introduce the wide seat design in order to avoid too short spindle service life due to the disc bottom burn-off. Therefore, it has been specified wide seat bottom piece on newbuilding's within the 50-70 bore segment since the beginning of 2014. Since mid-2016, the wide seat design has been standard on all newbuilding's regardless bore size. The bore cooled wide seat bottom piece and optimized seat angle was introduces primo 2019 in newbuilding's.

The ongoing trend of increased combustion chamber heat load has been forced to prioritize wide-seat design, in order to make sufficient spindle cooling, making the spindle bottom burn-off rate endurable. Also the enhanced cooling with wide seat, will make it possible to keep the spindle seat maximum temperature below a threshold limit.

However, a number of spindles suffering from the blow-by has been seen after having been in service for several years by applying wide seat design. We find that in case the spindle bottom burn-off rate are in the lower range, then the increasing number of dent marks that are accumulated on the seat's during service will most likely be the cause of reduced lifespan if not addressed.

Therefore, the exhaust valve grinding machine for exhaust valve spindle and seat will be introduced as a standard tool for new ordered all Hyundai-MAN B&W 2-Stroke engines since it is worthwhile to carry out seat preventive grinding. Preventive grinding of exhaust valve spindle seat and bottom piece has more advantage compares to the spindle reconditioning. This tool can be provided with extra cost for the ongoing projects, if requested.

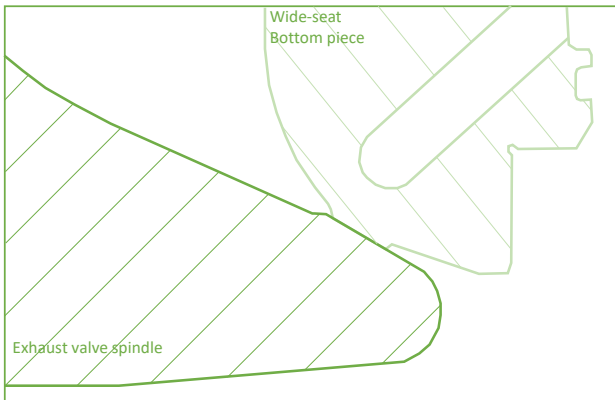
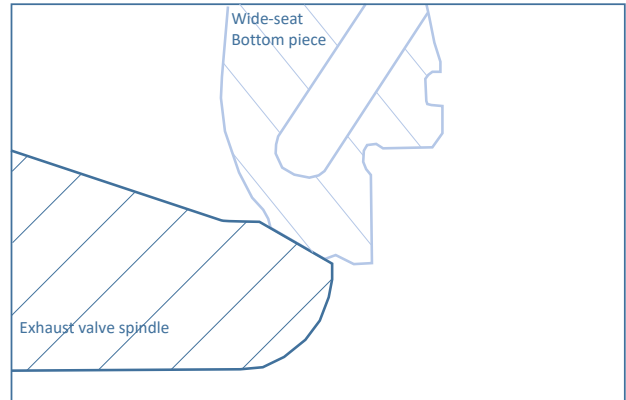
Spindle seat seen from top.

In the event of dent marks exceeding $\varnothing 2$ mm after 0.5 mm spindle seat grinding, evaluate according to the sketch below.

***) Seat contact area: spindle seat $><$ bottom piece seat.**

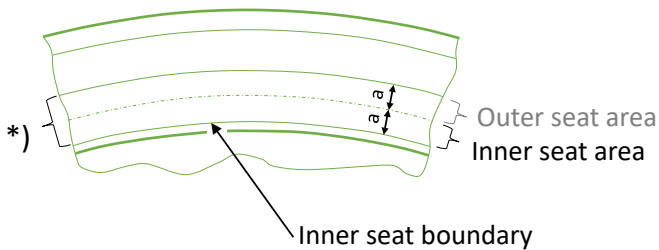
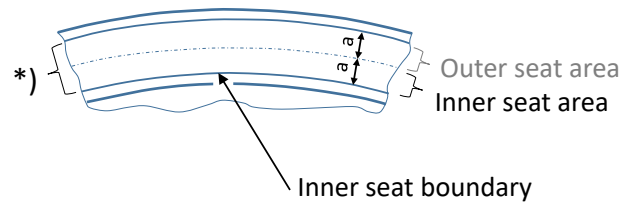
Spindle outer seat area

Dent marks exceeding $\varnothing 2$ mm can be allowed, but the size must not exceed 8 mm size in any direction, and the dent mark must not affect the inner seat area.

Spindle inner seat area

Dent marks exceeding $\varnothing 2$ mm cannot be allowed on the inner seat area, except if the following conditions are fulfilled for that particular dent mark:

1. Minimum distance from dent mark to inner seat boundary is above 4 mm.
2. No visible sign of V-shaped hot corrosion or “elephant skin” in connection to the dent mark.
3. Largest dimension of dent mark may not exceed 4 mm in any direction.

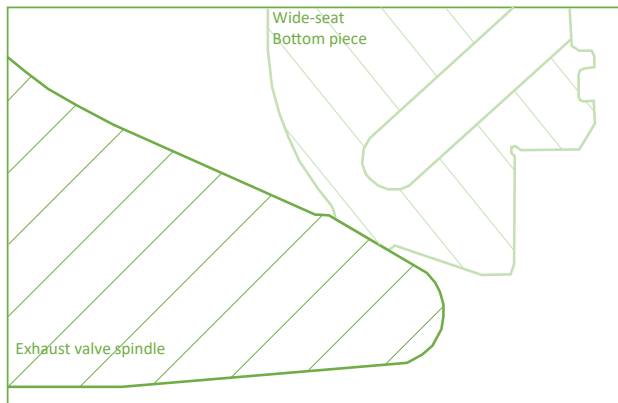
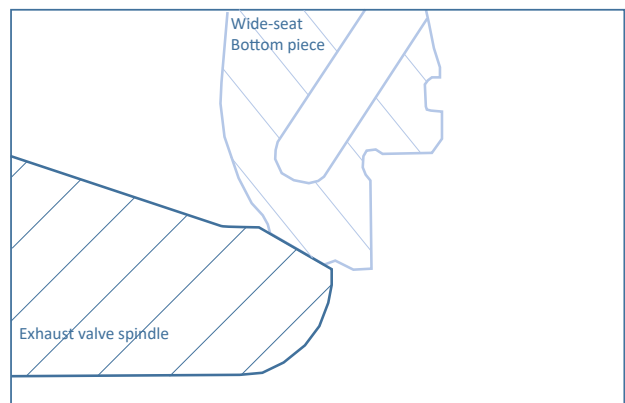
Spindle seat seen from top.

Defects necessitating rejection or repair.
The sketches below are valid for spindle seats.

*) Seat contact area: spindle seat >> bottom piece seat.
 All below examples to be rejected for further use.

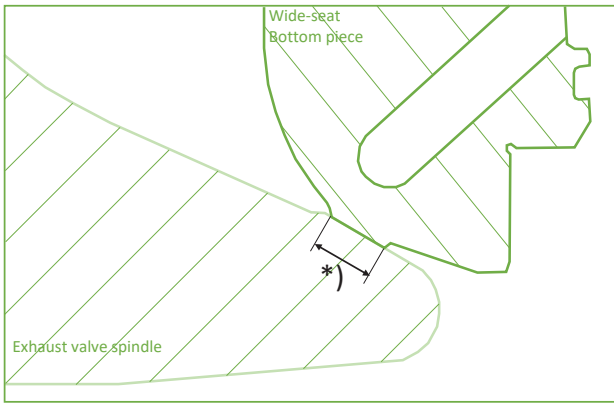
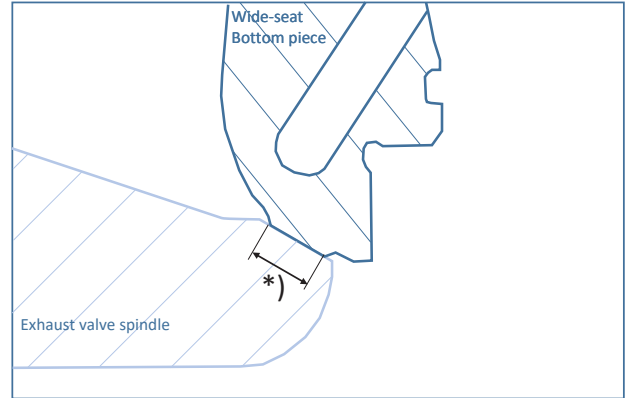
Bottom piece seat seen from below.

Service acceptance criteria for bottom piece seat.

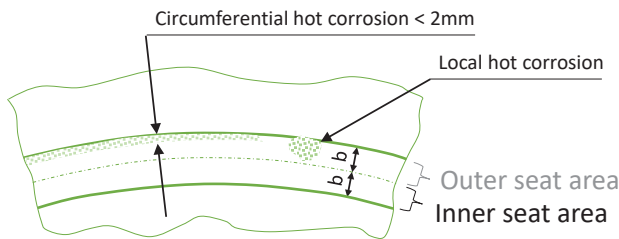
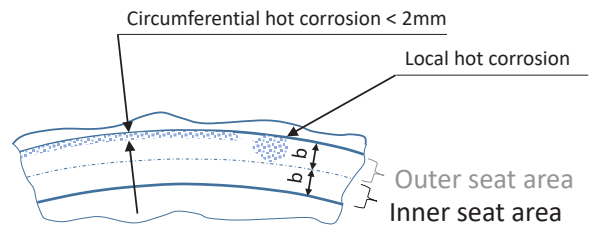
Bottom piece outer seat area

- Hot corrosion at the outer boundary of the bottom piece seat area must not exceed 2 mm width.
- Local hot corrosion on the bottom piece outer seat area, and only affecting the outer seat area, can be accepted if the maximum size in any direction does not exceed half the seat length. Half seat length indicated with “b” in the sketch above. Maximum one local hot corrosion spot of half seat length size can be accepted.
- Dent marks exceeding Ø2 mm can be allowed on the outer seat area provided that the inner seat area is unaffected.

Bottom piece inner seat area

Dent marks exceeding Ø2 mm cannot be allowed on the inner seat area, except if the following conditions are fulfilled for that particular dent mark:

1. Minimum distance from dent mark to inner seat boundary is above 4 mm.
2. Largest dimension of dent mark may not exceed 4 mm in any direction.
3. No visible sign of V-shaped hot corrosion or “elephant skin” in connection to the dent mark.

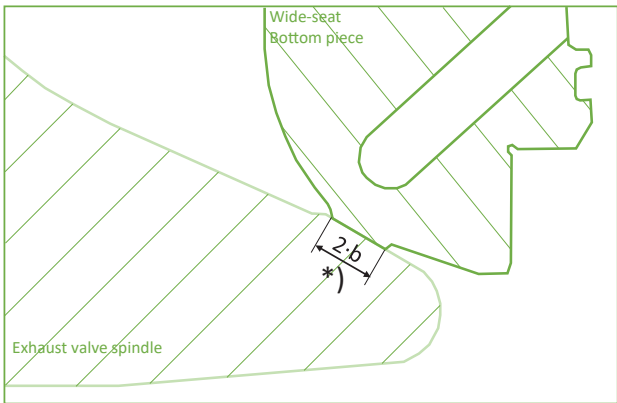
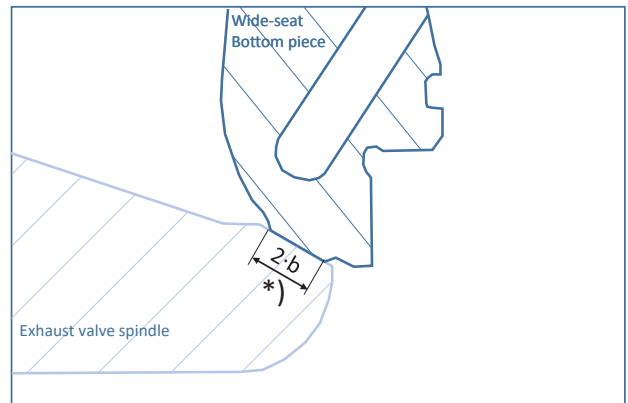
Bottom piece seat seen from below.

Defects necessitating rejection or repair.
The sketches below are valid for bottom piece seats.

All below examples to be rejected for further use.

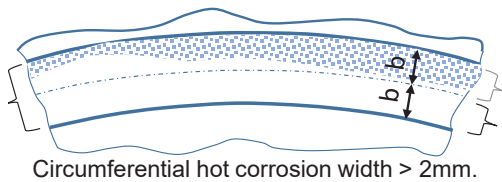
Outer seat area
 Inner seat area

Circumferential hot corrosion width > 2mm.
